**Ready-Mix Plant Improves Production by Solving Conveyor Tracking Problem**

<b>Industry</b>	Cement Producers and Distributors
<b>Application</b>	Wash Plant Conveyor
<b>Product</b>	Concrete, Aggregates
<b>Objective</b>	Conveyor Belt Tracking
<b>Conveyor</b>	50 ft long 10% incline, 48" wide belt 45° troughing idlers Conveyor runs intermittently

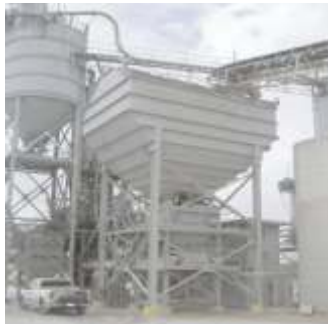
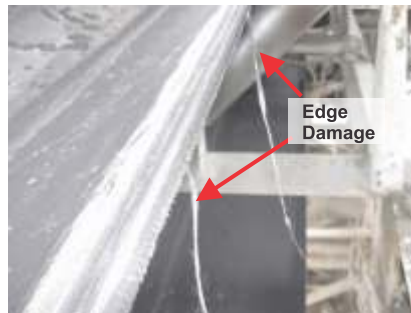
At one of these ready-mix plants they had difficulty training the vital conveyor belt that feeds the mixer. The problem presented was that the belt was difficult to train and had serious edge damage, causing de-lamination and spillage in the load zone due to the conveyor belt mis-tracking over the tail pulley. This was happening on a daily basis.

ASGCO worked in conjunction with the company's employees to re-align the idlers, tail pulley and determine the proper placement of the ASGCO Tru-Trainer. After a suitable location was determined, the work began. This particular location was chosen for the fact that it was close (20') from the tail pulley to insure the belt would track properly into the tail and there would be sufficient room for the install.

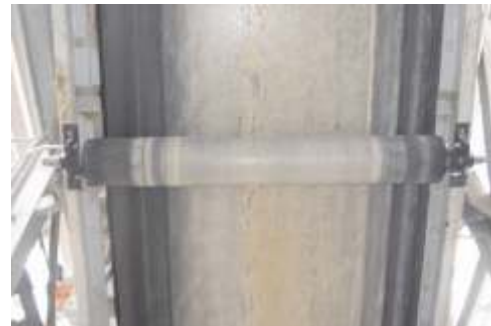
**After**

Tracking Perfectly. From the before and after picture you can see how effective the Tru-Trainer is at maintaining proper belt alignment. The plant manager is no longer concerned about the belt and is satisfied with the performance of the Tru-Trainer and can now focus on increasing production.

After the initial installation the return Tru-Trainer and some adjustments of the idlers and the tail pulley we were able to keep the belt within acceptable parameters, even under heavy use. The belt no longer walks off into the frame-work causing costly damage or downtime.
